# Manhole Inspection Summary

Manhole # S21K\_\_030MH

**Location** Address: **213 MONROE ST**

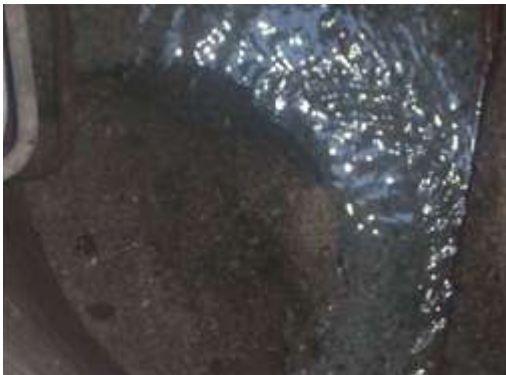
Defect 4

Condition: ☐ Sound ☐ Cracked ☐ Root Intrusion ☒ **Deteriorated** ☐ Leaks ☐ Debris

BENCH DETERIORATION

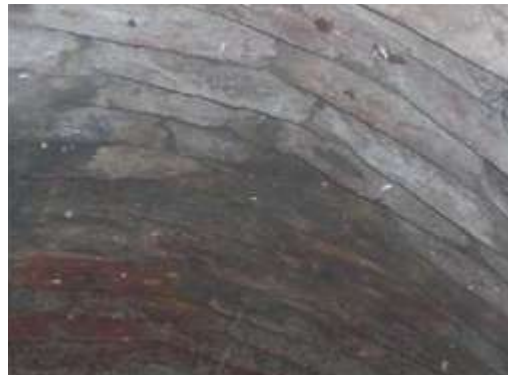
Defect 3

Infiltration: ☐ None ☐ Joint ☐ Cracks ☐ Mortar ☐ Roots ☒ **Wall**

INFILTRATION OF CORBEL

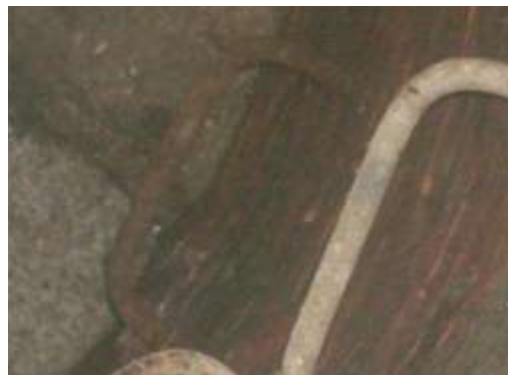
Defect 1

Count: **6** Missing: **0** ☒ **Corroded**

CORRODED STEPS

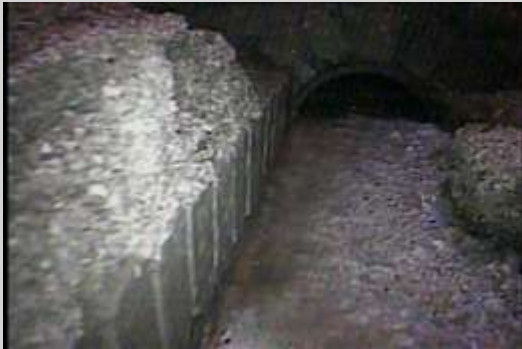
12 O'Clock Outflow

Pipe Height: **8.4** (in.) Rod and Bar (Angled)  
Pipe Material: **Clay** ☐ Pipe Lined  
Invert Depth: **10.61** (ft.) Flow Characteristics: **Slow**  
Deposits: ☐ None ☐ Mud ☒ **Sludge** ☐ Debris ☐ Grease  
Silt Depth: **4** (in.) Deposits Extent: **Heavy**  
Infiltration: **None** Pipe Seal Cond: **Sound**

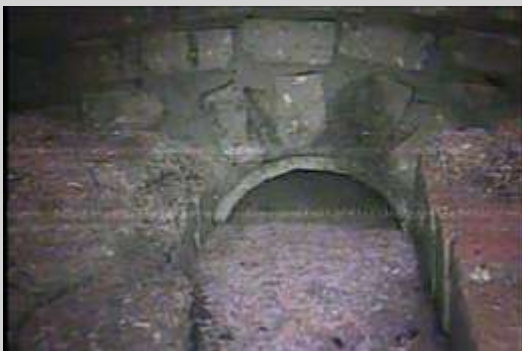
3 O'Clock Inflow

Pipe Height: **8.4** (in.) Rod and Bar (Angled)  
Pipe Material: **Clay** ☐ Pipe Lined  
Invert Depth: **10.66** (ft.) Flow Characteristics: **Slow**  
Deposits: ☐ None ☐ Mud ☒ **Sludge** ☐ Debris ☐ Grease  
Silt Depth: **5** (in.) Deposits Extent: **Heavy**  
Infiltration: **None** Pipe Seal Cond: **Sound**
